Unmanned Aircraft System Bridge Inspection Demonstration Project Phase II

Barritt Lovelace, Principal Investigator
Collins Engineers, Inc.

June 2017

Research Project
Final Report 2017-18

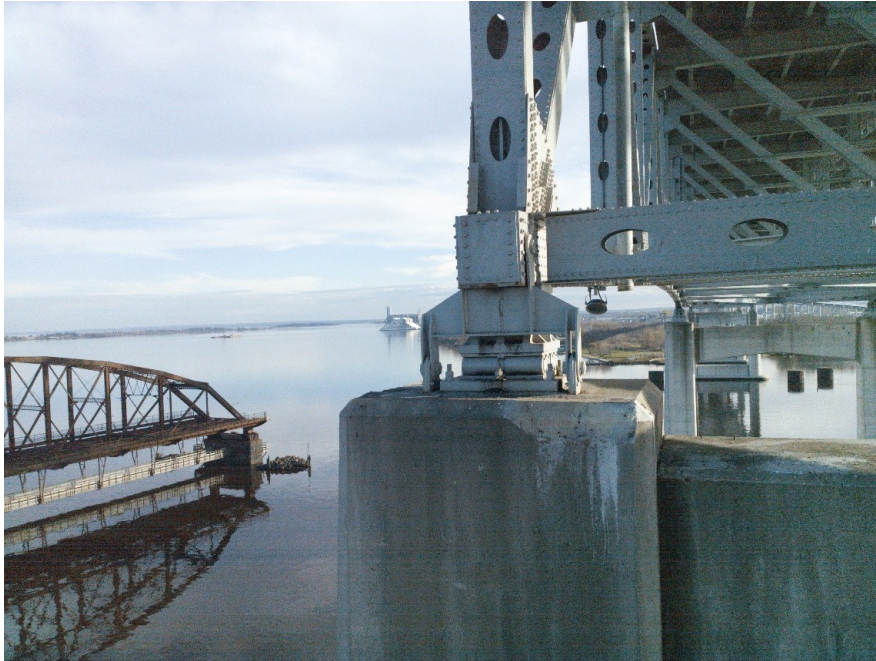
Figure 5-7 Photograph of Blatnik Bridge Bearing.

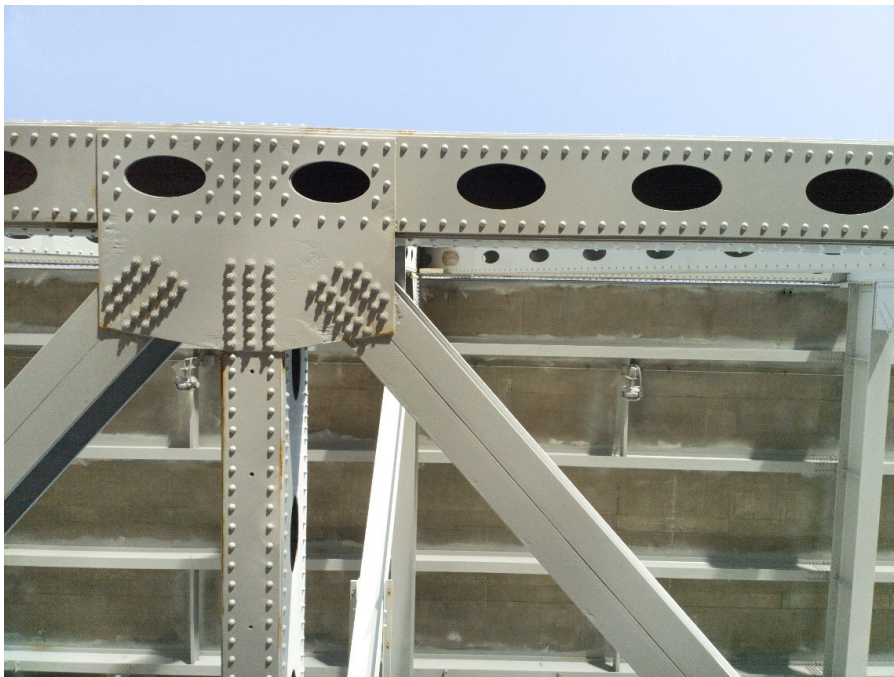
Figure 5-10 Photograph of Blatnik Bridge Underside Truss Connection.

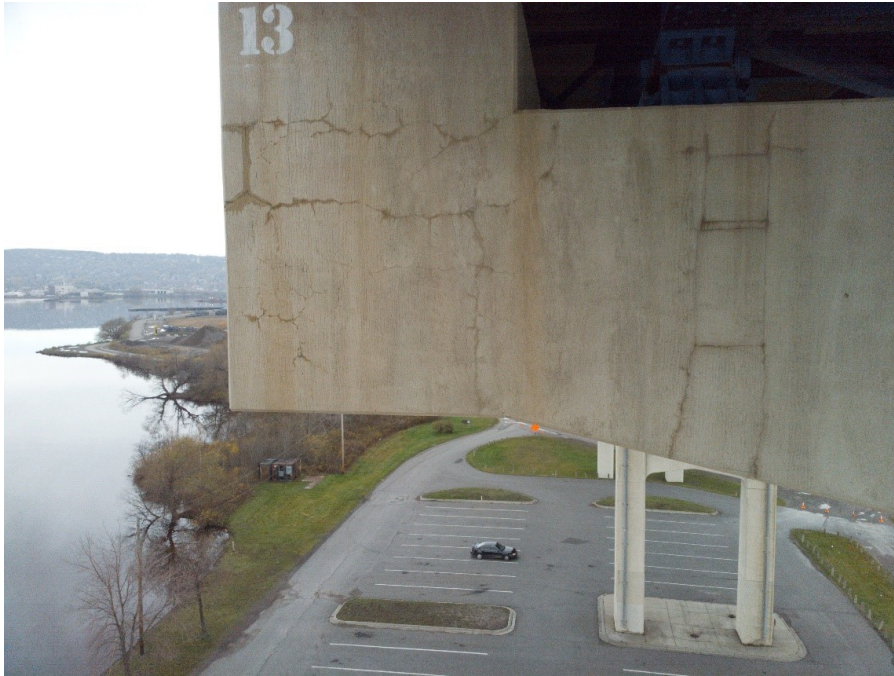
Figure 5-11 Photograph of Blatnik Bridge Pier Cap Detail.

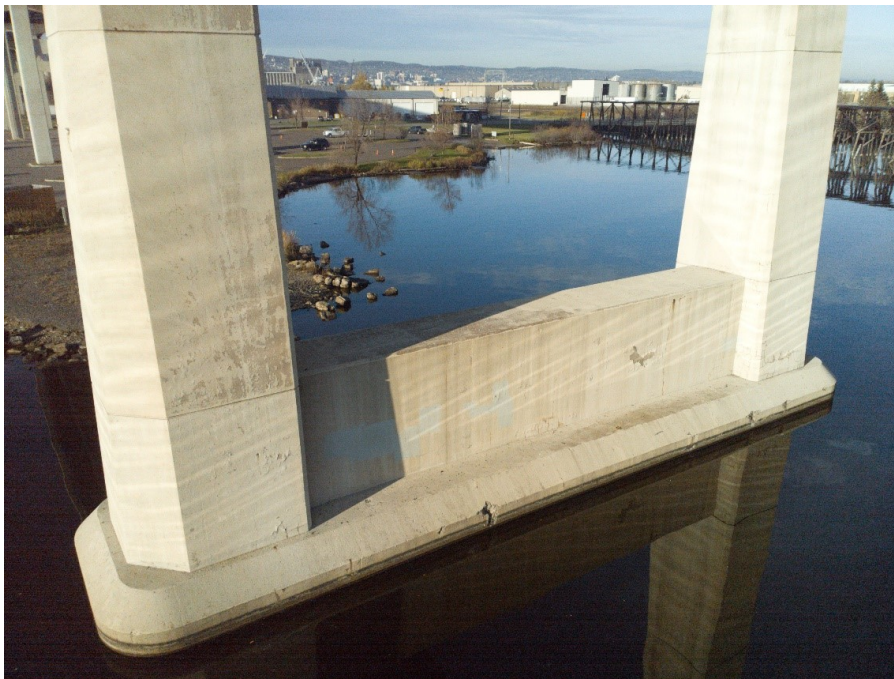
Figure 5-12 Photograph of Blatnik Bridge Pier at Waterline.

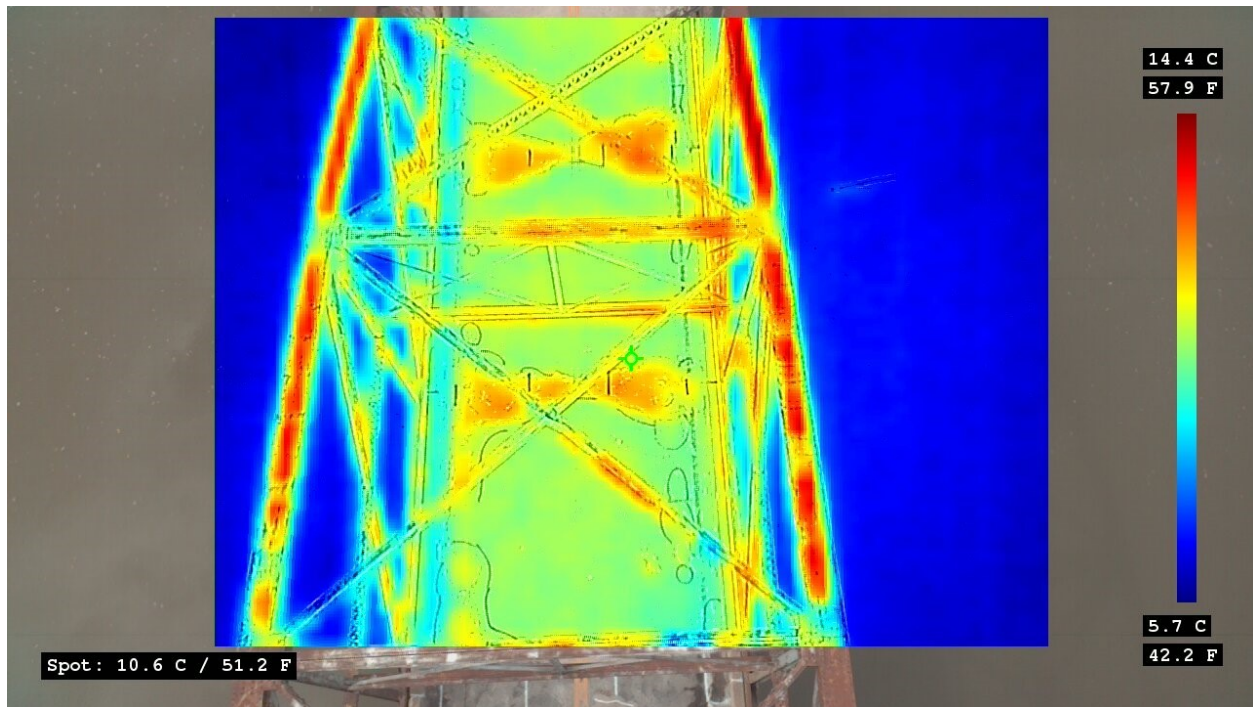
bridge was first chain dragged in order to locate and mark observed deck delaminations. The drone was then flown over the bridge with the thermal sensor active while thermal images were collected. Handheld FLIR thermal cameras were also used as a comparison.

Figure 5-15 Bridge 5767 Deck Drone Thermal Images.

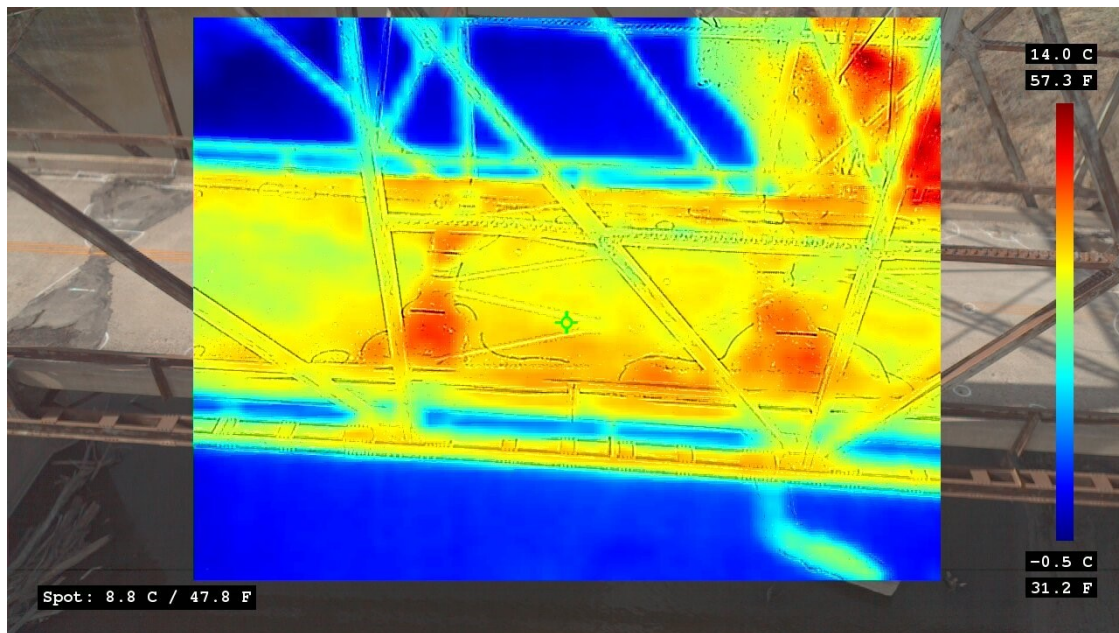
Figure 5-16 Bridge 5767 Deck Drone Thermal Image.

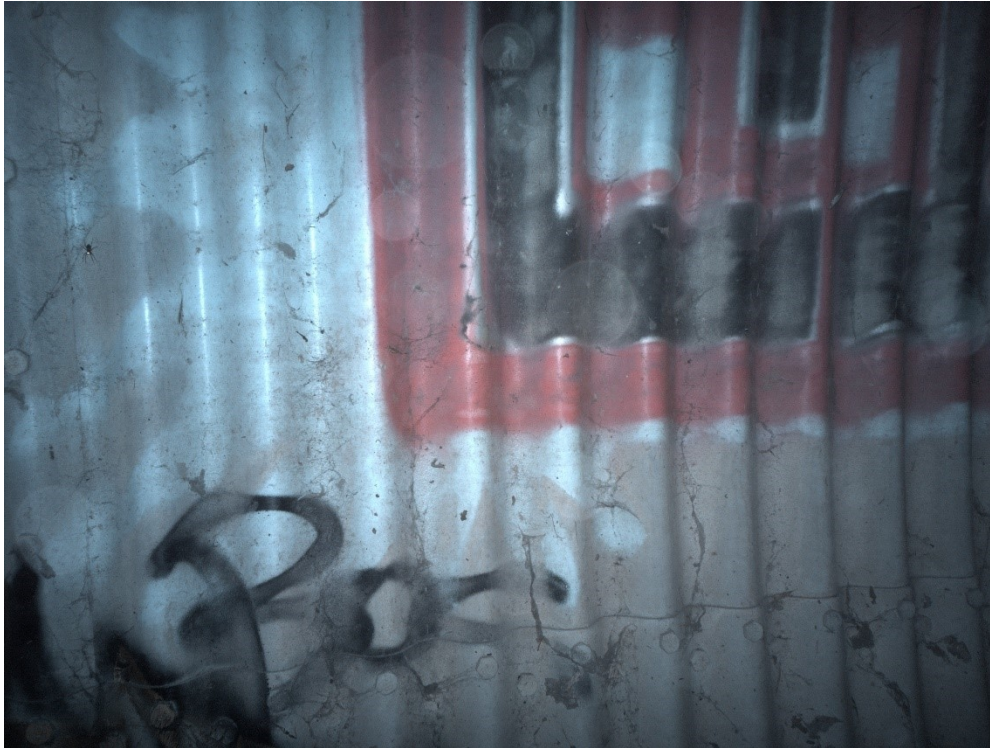
Our team was able to fly the UAS longitudinally through the culvert taking photos and video of the interior (Figure 5-19). Photo and video quality were good and provided enough detail to discern deficiencies. The LED light and flash were able to illuminate the structure to improve the quality of photos and video.

Figure 5-20 Photograph of Culvert Interior Wall.

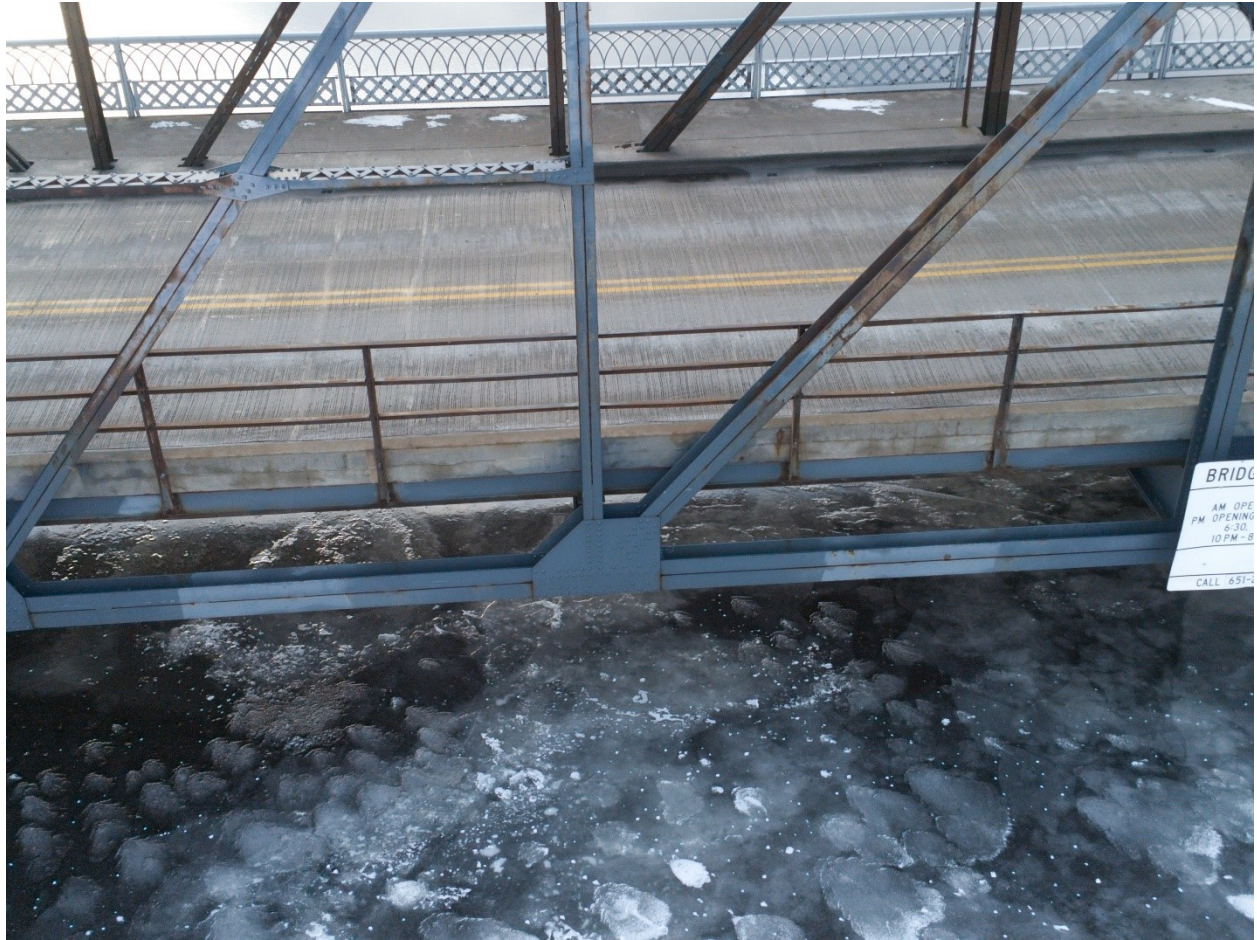
The UAS was flown from end to end using the Albris' cruise control feature and automatic photo triggers. HD video was also taken and the photos and videos were used to determine the condition of the railing and was useful in the decision to ultimately replace the railing. This effort provided the designers with enough information to make an informed decision on whether to replace the railing and was done cost effectively without disrupting traffic at any time. The alternative would have included traffic control and would have been considerably more expensive and time consuming.

Figure 5-24 Typical Railing View.

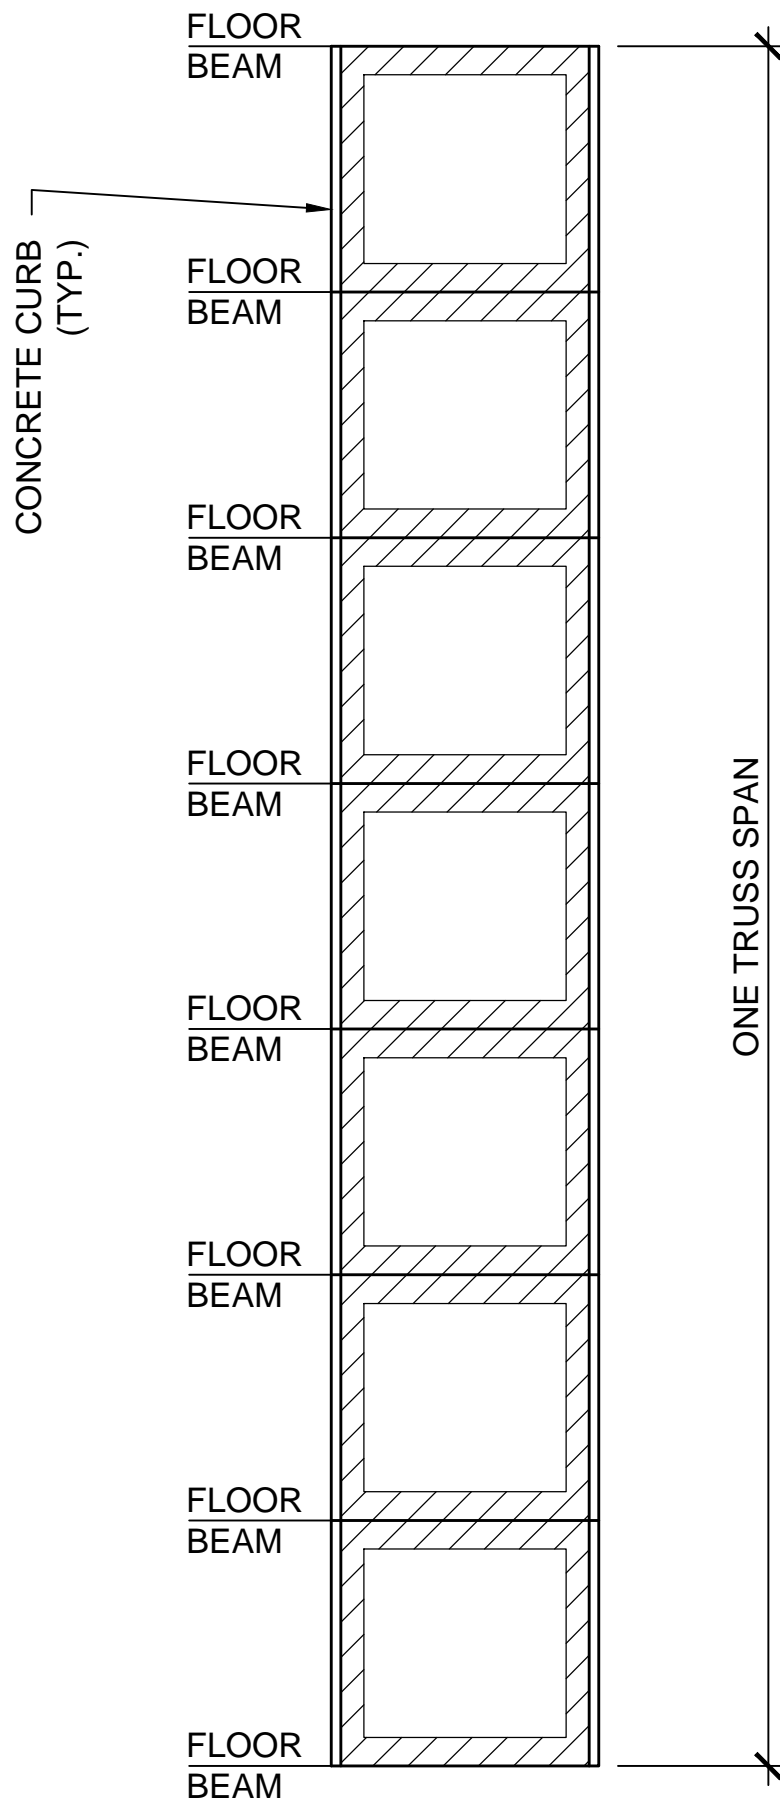
APPROXIMATE AREA
OF UNSOUND CONCRETE

A chain survey will not reveal the depths of the unsound concrete. Based on the hole that that recently formed in the deck, it is likely that the deteriorated concrete extends nearly full depth in the areas over the floor beams. Depths of the unsound concrete would have to ultimately be verified with concrete coring. At this point, our recommendation is to further investigate the extent of deterioration of the concrete deck prior to initiating any repairs or reopening the bridge.
